# Manhole Inspection Summary

Manhole # S21I\_\_018MH

Insp Date: **9/21/07 7:09 AM**

**Location** Address: **105 ADDISON ST**

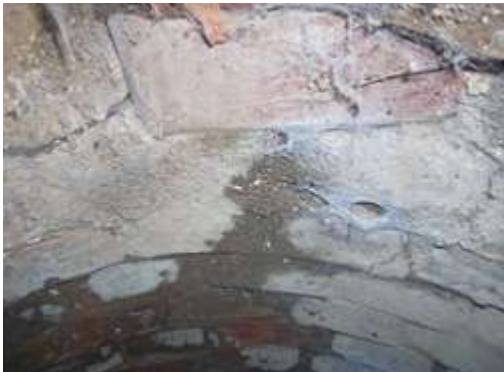
Defect 5

Infiltration: ☐ None ☒ **Joint** ☐ Cracks ☐ Mortar ☐ Roots ☒ **Wall**

INFILTRATION OF CHIMNEY JOINT

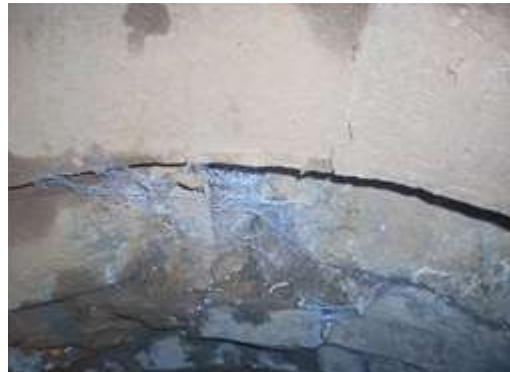
Defect 4

INFILTRATION OF CHIMNEY WALL

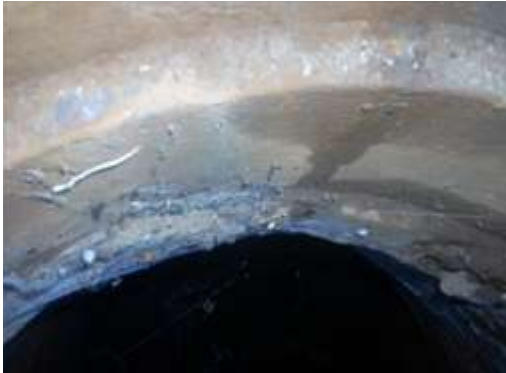
Defect 3

Condition: ☐ Sound ☐ Cracked ☐ Root Intrusion ☐ Loose Brick ☒ **Deteriorated**

DETERIORATED CHIMNEY

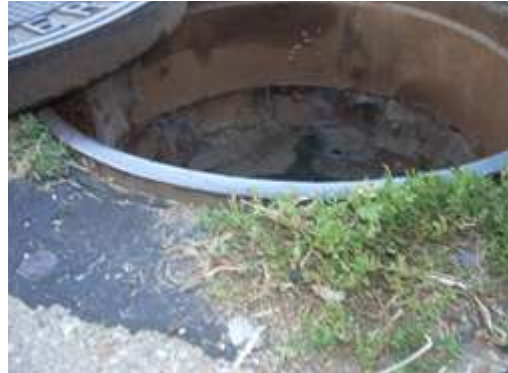
Defect 2

Offset: **1** (in.)

FRAME OFFSET

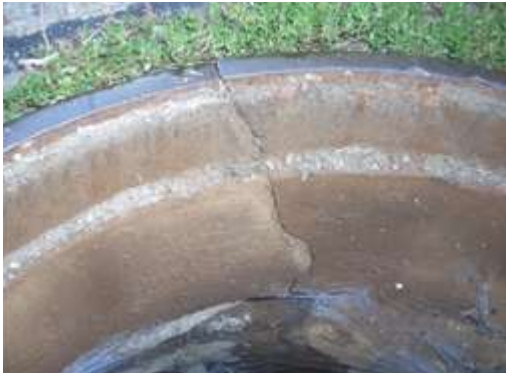
Defect 1

Diameter: **24** (in.) Length: (in.) Dist A/B Grade: **1** (in.)

GRADE ADJUSTMENT

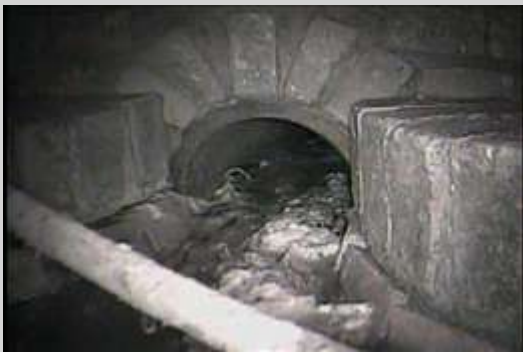
12 O'Clock Outflow

8 in. Circular Gravity Sewer  
Pipe Out @ 12 O'Clock

Pipe Height: **7.2** (in.) Rod and Bar (Angled)  
Pipe Material: **Clay** ☐ Pipe Lined  
Invert Depth: **9.79** (ft.) Flow Characteristics: **Slow**  
Deposits: ☐ None ☐ Mud ☐ Sludge ☒ **Debris** ☐ Grease  
Silt Depth: **3** (in.) Deposits Extent: **Medium**  
Infiltration: **None** Pipe Seal Cond: **Sound**

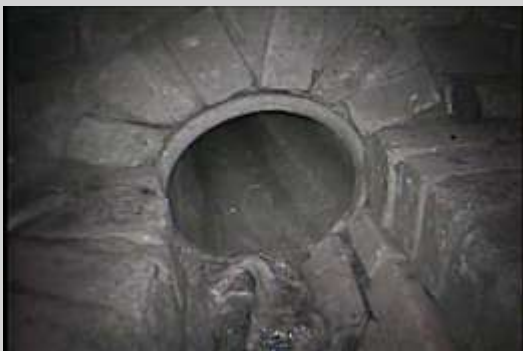
3 O'Clock Inflow

8 in. Circular Gravity Sewer  
Pipe In @ 3 O'Clock

Pipe Height: **8.4** (in.) Rod and Bar (Angled)  
Pipe Material: **Clay** ☐ Pipe Lined  
Invert Depth: **9.24** (ft.) Flow Characteristics: **None**  
Deposits: ☒ None ☐ Mud ☐ Sludge ☐ **Debris** ☐ Grease  
Silt Depth: (in.) Deposits Extent:  
Infiltration: **None** Pipe Seal Cond: **Sound**

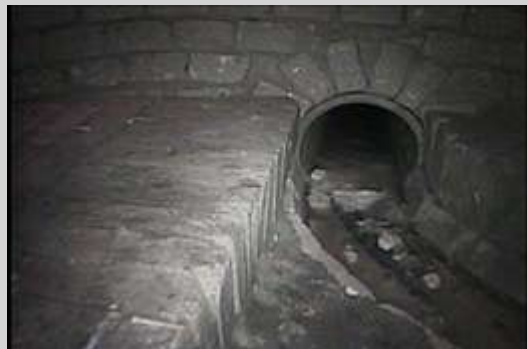
9 O'Clock Inflow

8 in. Circular Gravity Sewer

Pipe In @ 9 O'Clock

Deposits: ☐ None ☐ Mud ☐ Sludge ☒ **Debris** ☐ Grease

Silt Depth: **1** (in.) Deposits Extent: **Light**
